IMCA Safety Flash 17/15

October 2015

I High Potential Near Miss: Failure of Lifeboat Release Hook Mechanism

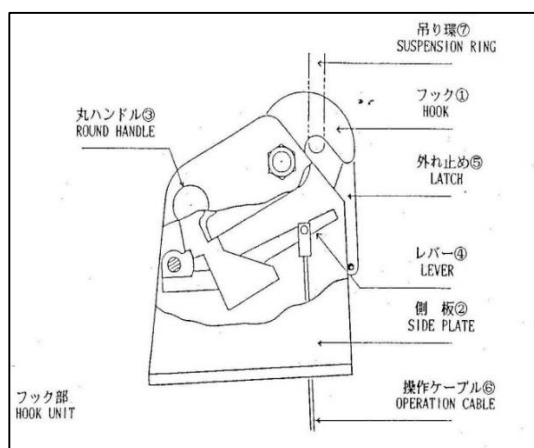
Figure 1: Basic overview of lifeboat release hook

The release hook system in place on board the vessel was of the Nishi-F Company on/off load release type. The basic overview of the system is shown in Figure 1 below, with the components noted.

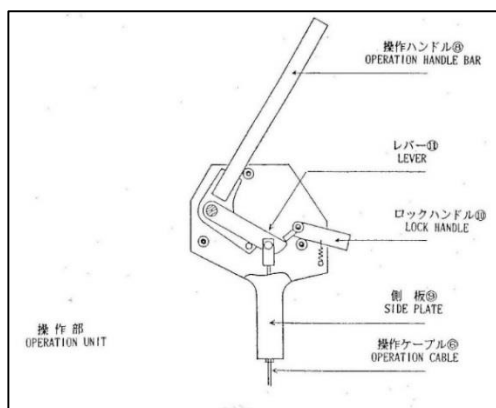
Figure 2: Showing operation unit

To release the lifeboat, a crew member in the lifeboat pulls a locking handle bar upwards and whilst holding the handle bar in the lifted position, operates the release. In consequence the hook units on the forward and aft are simultaneously released from the suspension rings as the operation cable manipulates the lever. See figure 2 below.
