IMCA Safety Flash 17/19

July 2019

Dropped Objects

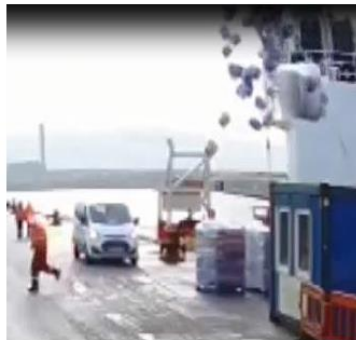
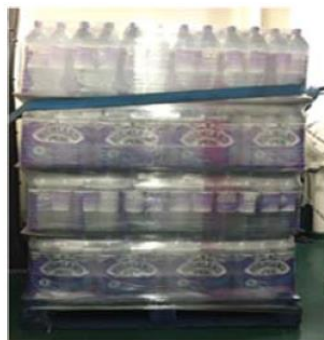
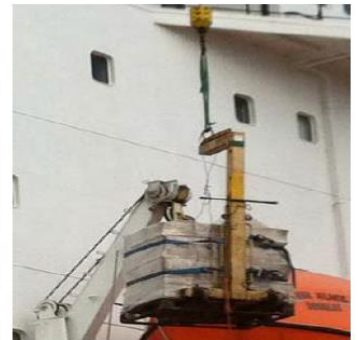
Falling pallet during lifting operations

Example of pallet loaded with water bottles and pallet lifter

Inattention, complacency and failure to follow company lifting procedures with regards to lift team size.
