IMCA Safety Flash 29/17

November 2017

Summary

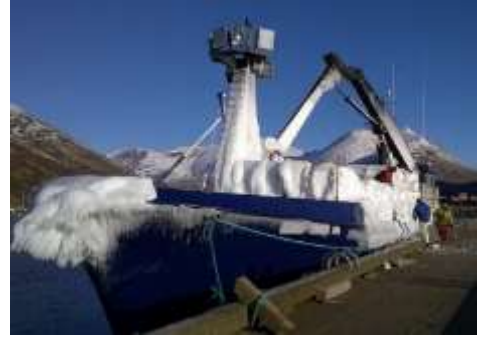
The United States Coast Guard (USCG) has published Safety Alert 11-17 relating to vessel stability and watertight integrity. Recently, a marine casualty involving a fishing vessel in the Bering Sea resulted in multiple fatalities and complete loss of the vessel.

A Marine Board of Investigation is currently analyzing the various circumstances surrounding the casualty. Although the investigation is not complete, testimony and fact finding indicate that vessel owners, operators, and crews should give special consideration to vessel stability concerns.

The need for operators to understand their vessel's Stability Instructions (SI) cannot be overstated. It is important to understand the document. Operators and crew should seek out opportunities to further their knowledge of stability via courses, training, workshops, and visits from Naval Architects. They should also take advantage of other various initiatives, both mandatory and voluntary, to discuss and compare a vessel's current SI to the actual loaded condition prior to departing port. An independent review of a vessel's loaded condition, equipment, and operations can often provide important insights.
