## IMCA Safety Flash 31/16

November 2016

### Focus: Diving Incidents

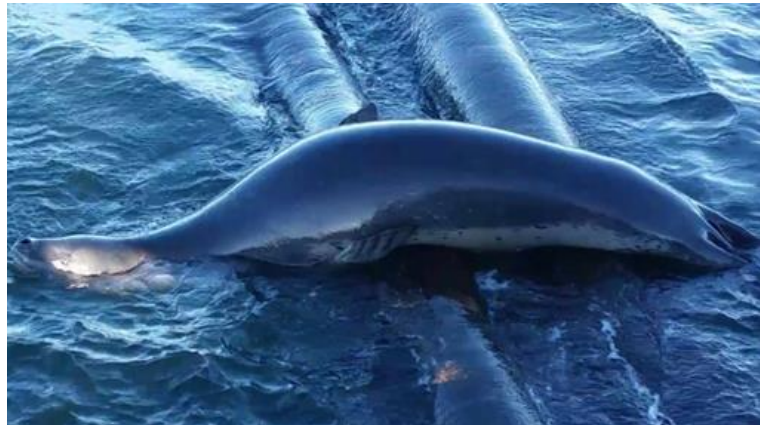
In the first instance the animals were displaying a high level of curiosity, showing a gaping mouth and fast circling around the diver. The diver was safely recovered to the LARS basket and brought back to surface as the Leopard Seal got closer and closer. The Leopard Seal continued to

remain in the area, beaching itself on the floating hoses, but after a period of no sightings, diving operations were resumed.

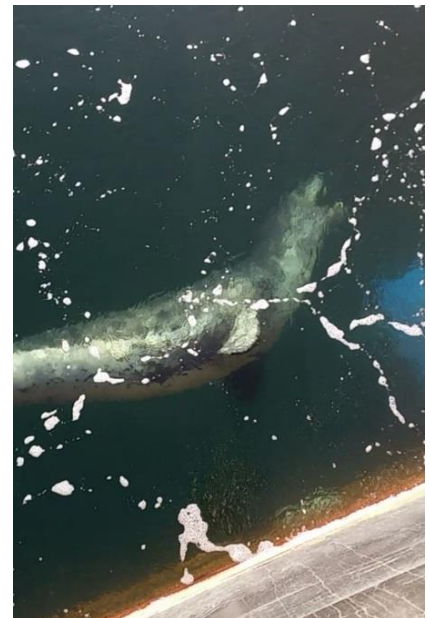
A week later the diver was working on the subsea valves when he received a strong push from behind. The diver took refuge between the valves whilst the animal closely investigated the diver, again with high speed swimming and a wide open mouth. The diver was brought back to the LARS basket and recovered to surface but the seal forced the diver to take refuge in the bottom of the basket during the ascent. The diver was badly shaken by the experience.

- ♦ A watch for marine mammals should be in place for 30 minutes before starting a dive;
- ♦ The marine mammal watch should be maintained throughout diving operations. If a Leopard Seal, or an Orca (killer whale), be seen, this is to be communicated to Dive Control and the diver recovered to deck;
