IMCA Safety Flash 21/20

July 2020

1 Double Man Overboard Resulting in one Fatality

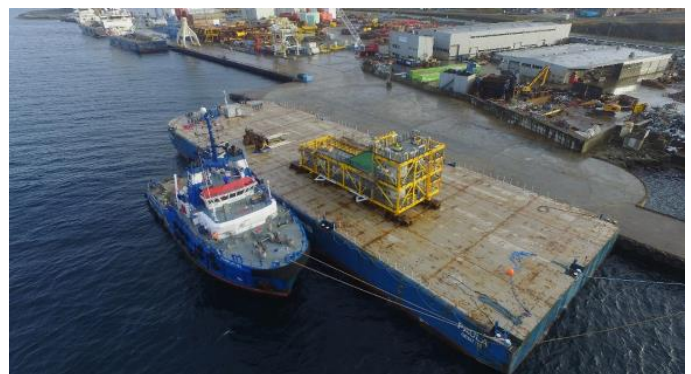
- ◆ Vessel to vessel transfer was accepted and regarded as a routine activity;
- ◆ Risk awareness did not deal with specific risks of routine activities in non-routine circumstances. The focus is on what has to be done, not on how/risks involved;
- ◆ MOB between two stationary vessels was not specifically addressed in procedures, risk assessments or drills related to MOB. Rescue equipment was not primarily suitable for rescuing MOB from between two vessels.

Our member notes that both the AB and the 2nd Mate were wearing inflatable lifejackets which slipped up their heads whilst they were in the water.

- Review MOB procedures and drills to include MOB situations between two stationary vessels/between vessel and quayside;
 - Ensure that toolbox talks not only deal with what has to be done, but also with how it should be done and the specific situational risks involved, including changes in operating conditions. Ensure that when work cannot be carried out safely anymore, the **Stop Work authority** is applied.

- Consider introducing life jackets with crotch straps.
